# **IDEaS CDIS Sandbox**

Visiooimage Inc. Infrared Thermography NDT with Eddy Current/Induction Heating Report version 2023-06-09 – Rev. G

COVE, Darthmouth, May 9-13<sup>th</sup>, 2022 To IDEaS for the CDIS sandbox by Clemente Ibarra, PhD Matthieu Klein, MSEE

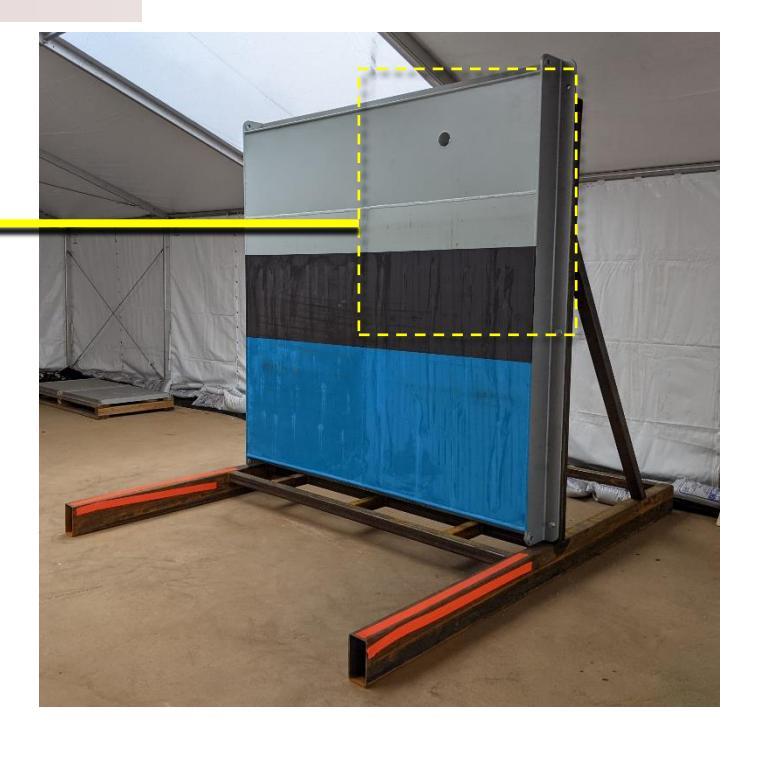
Advanced processing with PCT EOF5 using 91 frames can clearly reveal the pitting corrosion.

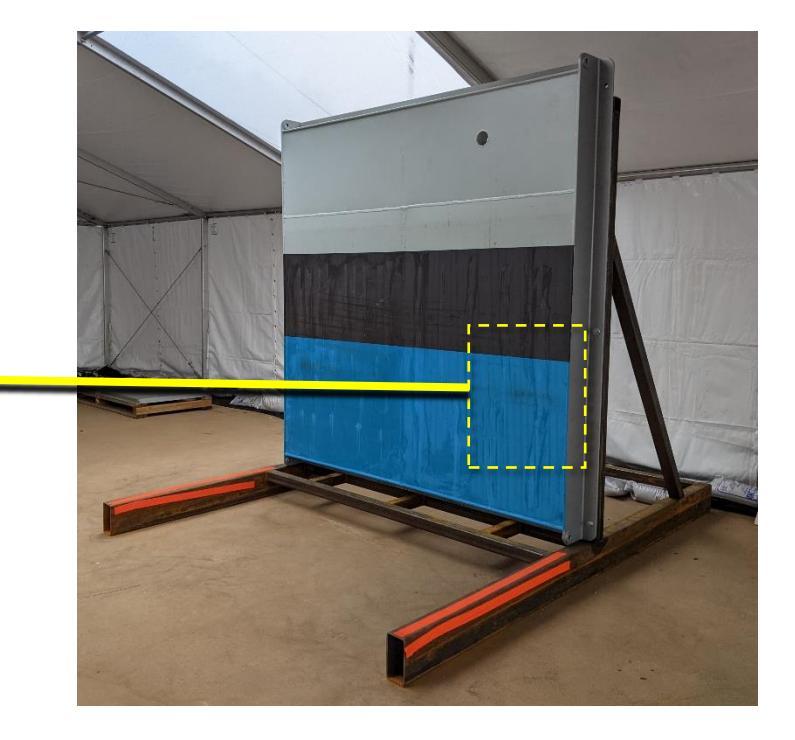
Advanced processing with PCT EOF3 using 69 frames can clearly reveal the pitting corrosion.

Pitting visible in RAW.

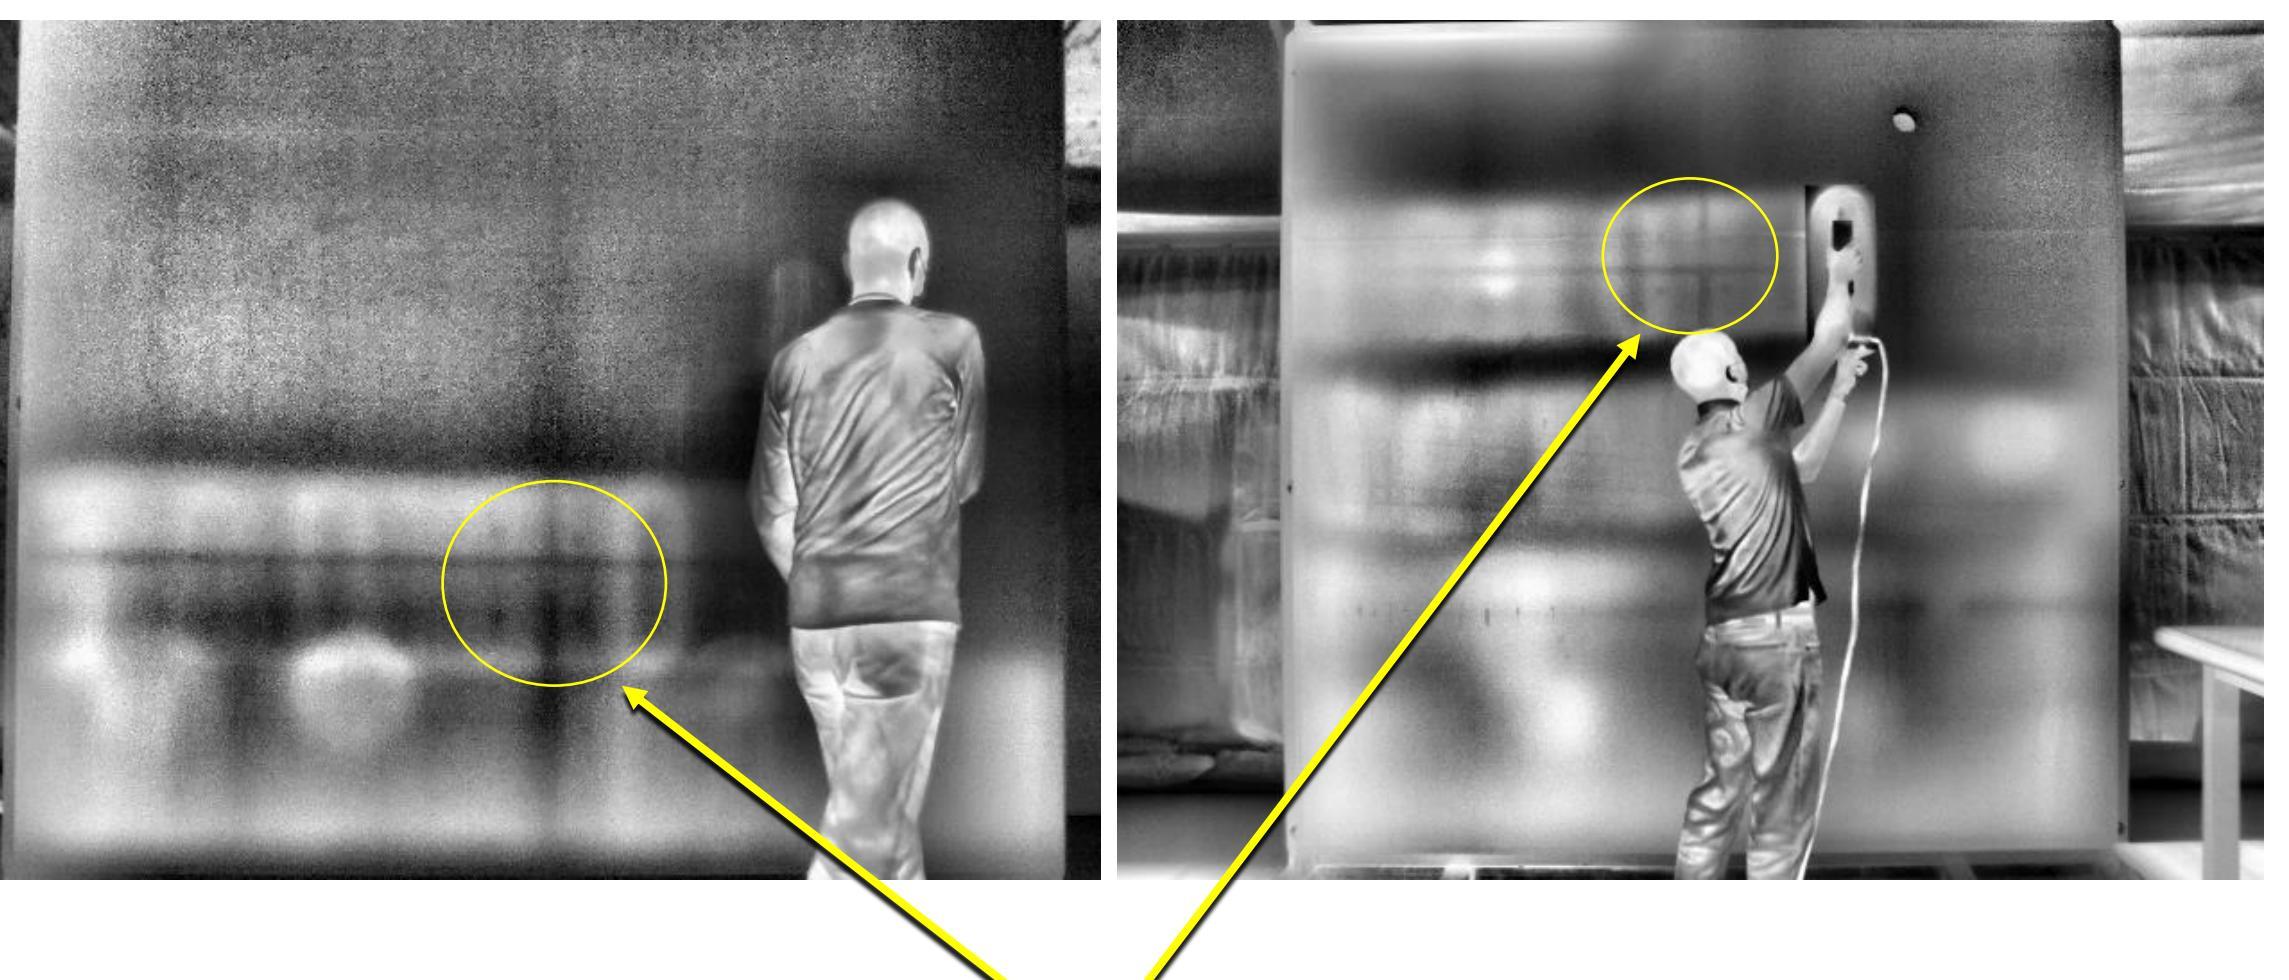
There are two groups of four darker spots, possibly indicating the presence of fasteners.

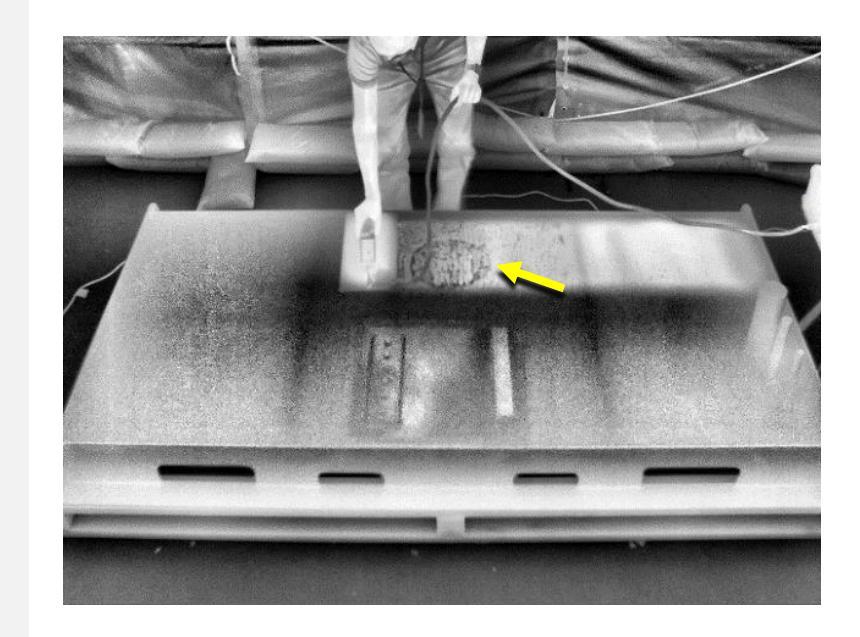
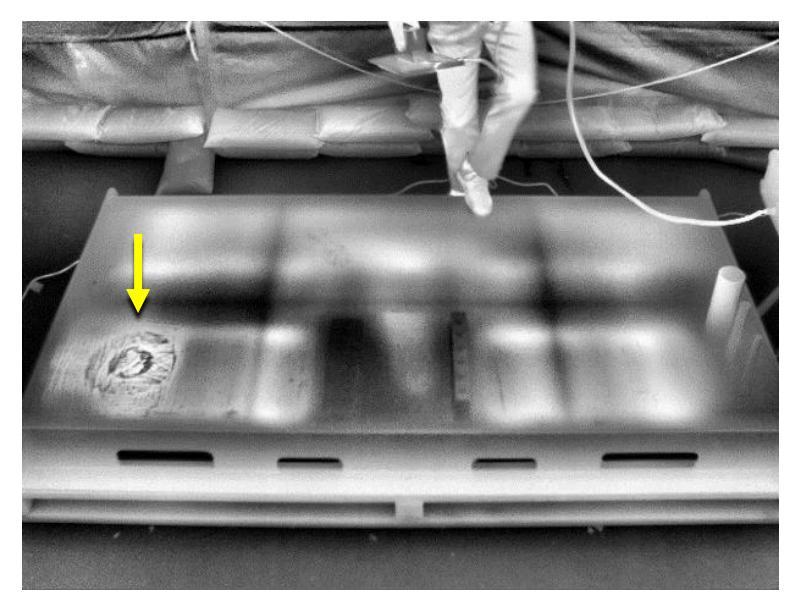
Note: The two FBH circles were visible to the naked eye. The embossing may have assisted or contributed to the infrared view.

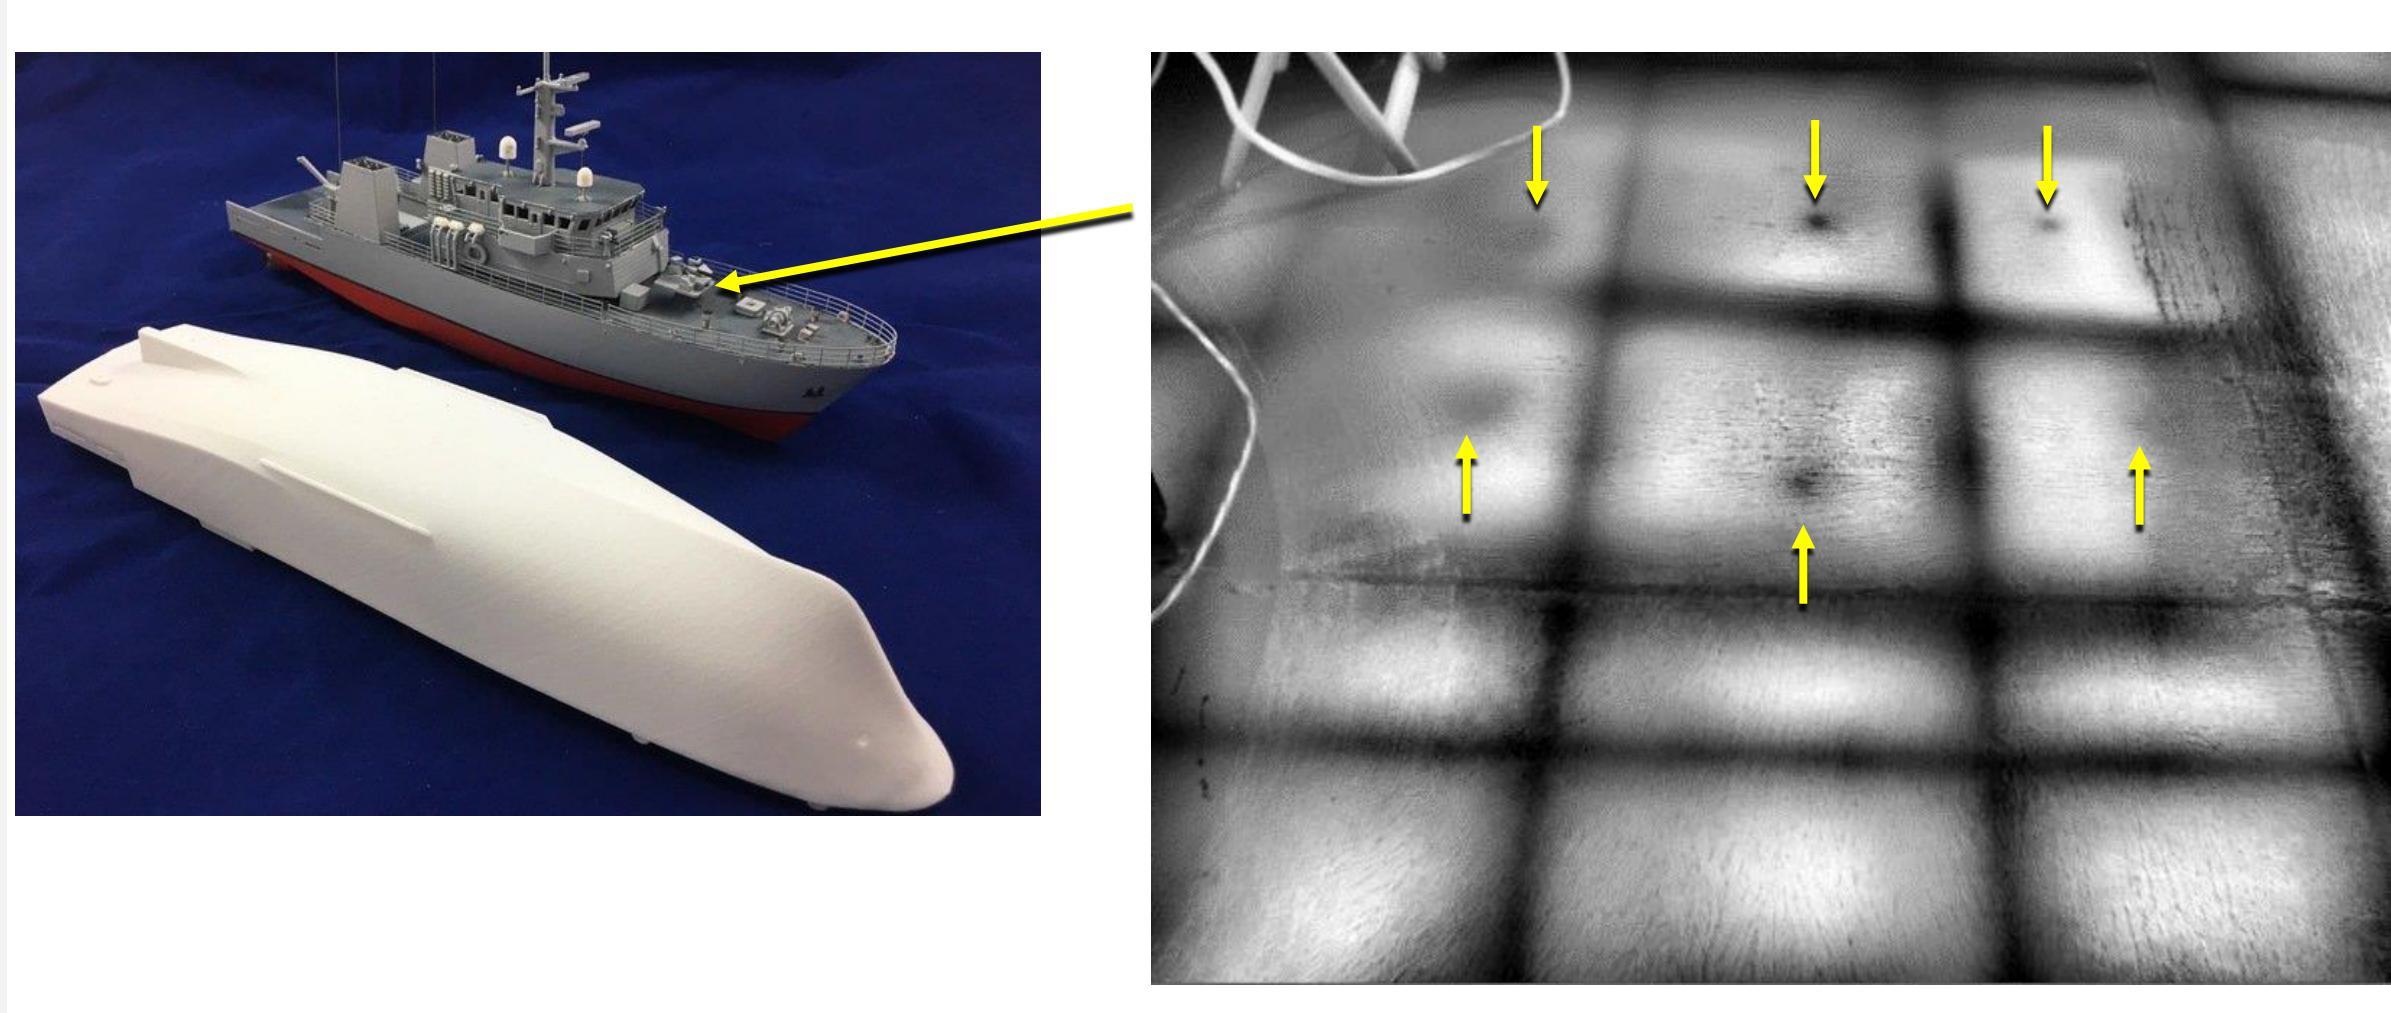
Above the refrigerating room: There are likely some fasteners or structural elements underneath the deck.

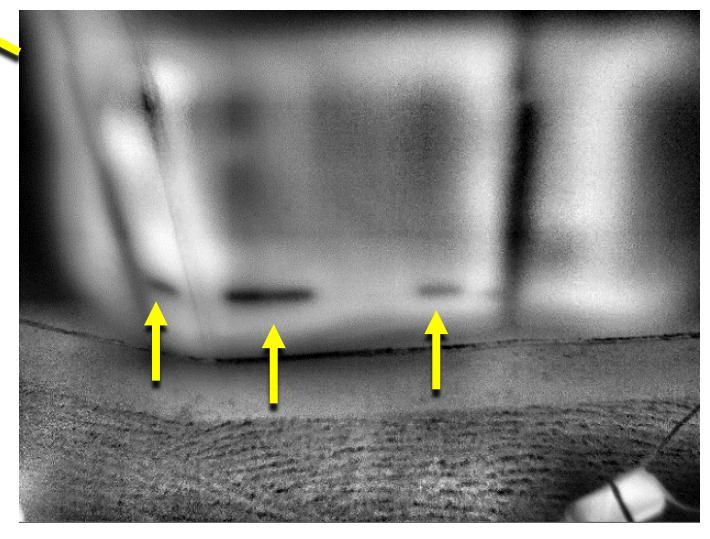
Side of the cabin, close to the ground/deck surface.

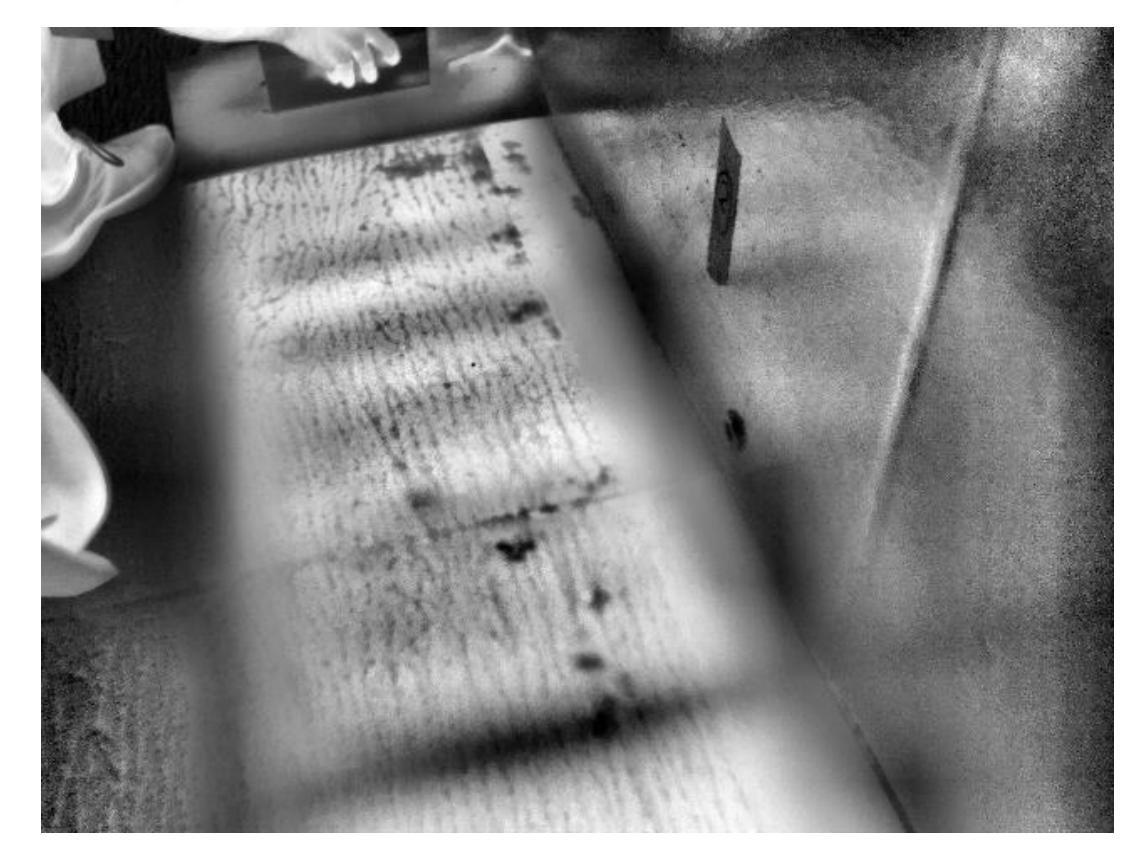
After heating, sub-paint surface corrosion, bubbles, and pitting (visible with the naked eyes) appear as black spots:

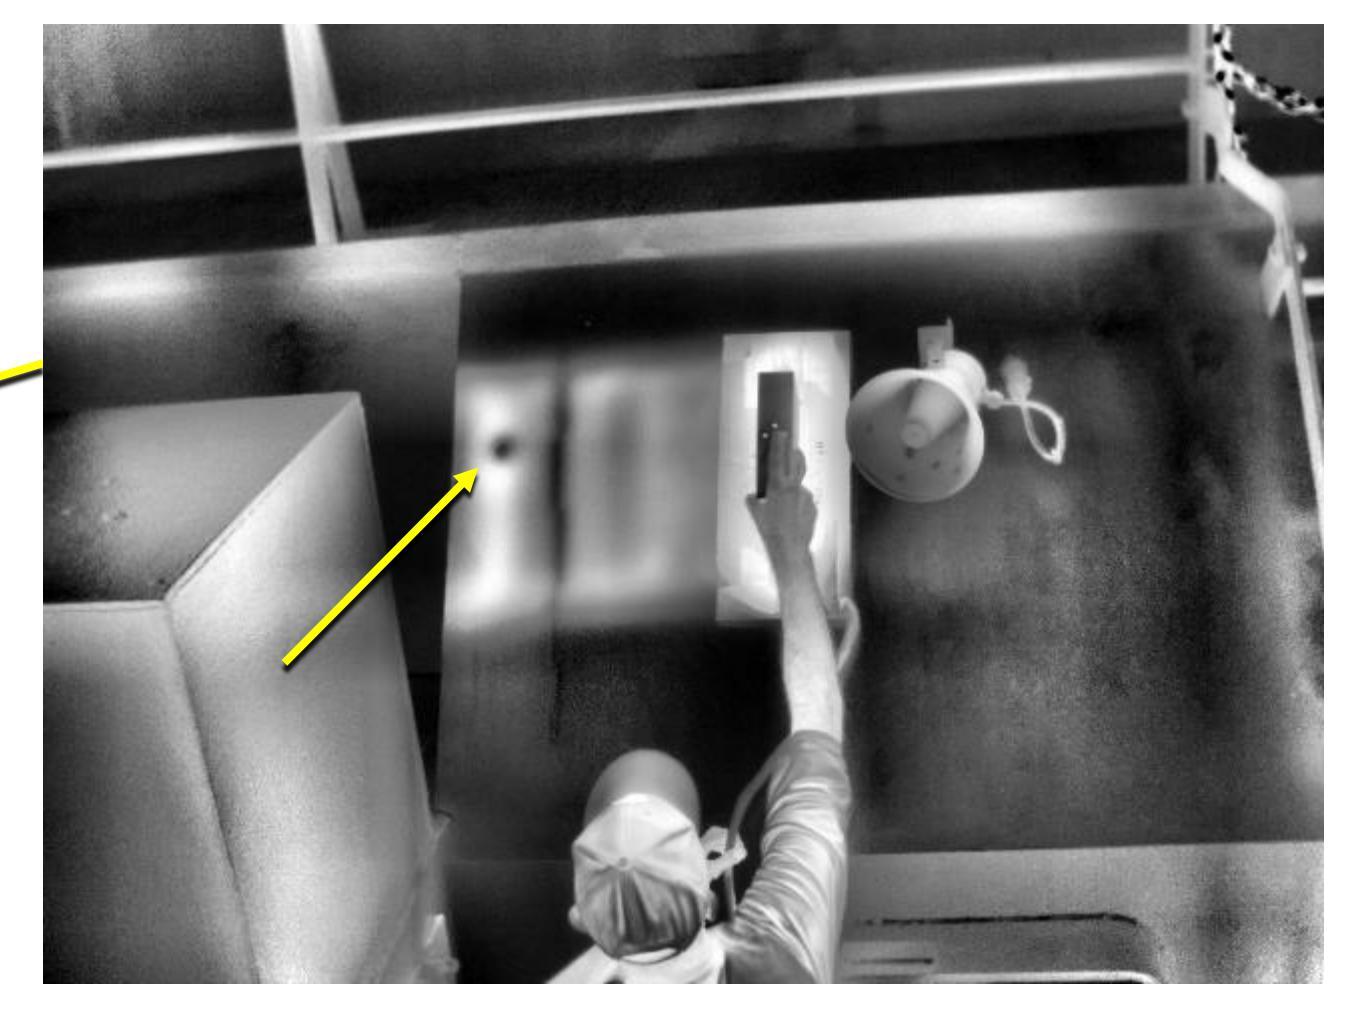
General corrosion spot hidden under the paint, with a visible cavity or lack of material that can be observed with the naked eye.

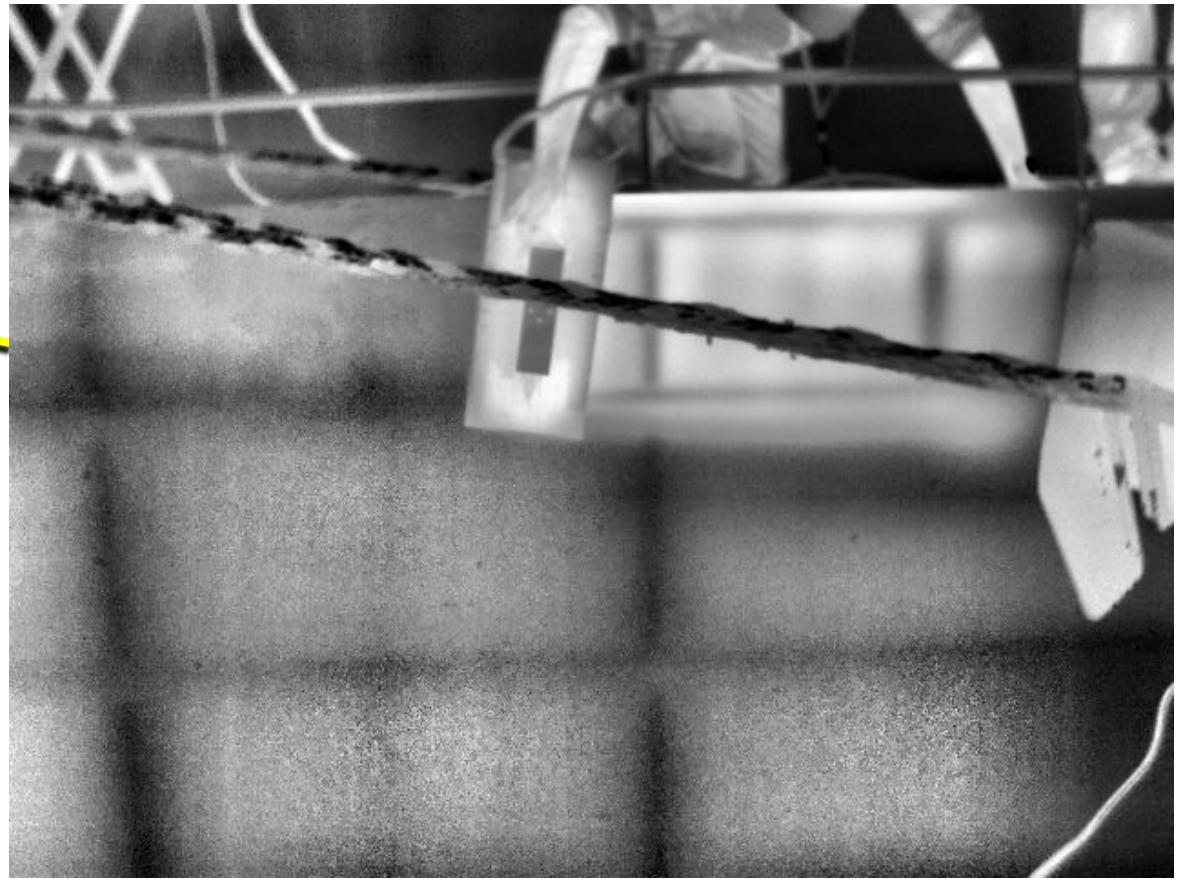
#### Upper hull accessible from the deck. Sound structure.
