# **IDEaS CDIS Sandbox**

Visiooimage Inc. Infrared Thermography NDT with Eddy Current/Induction Heating Report version 2023-06-09 – Rev. G

COVE, Darthmouth, May 9-13<sup>th</sup>, 2022 To IDEaS for the CDIS sandbox by Clemente Ibarra, PhD Matthieu Klein, MSEE

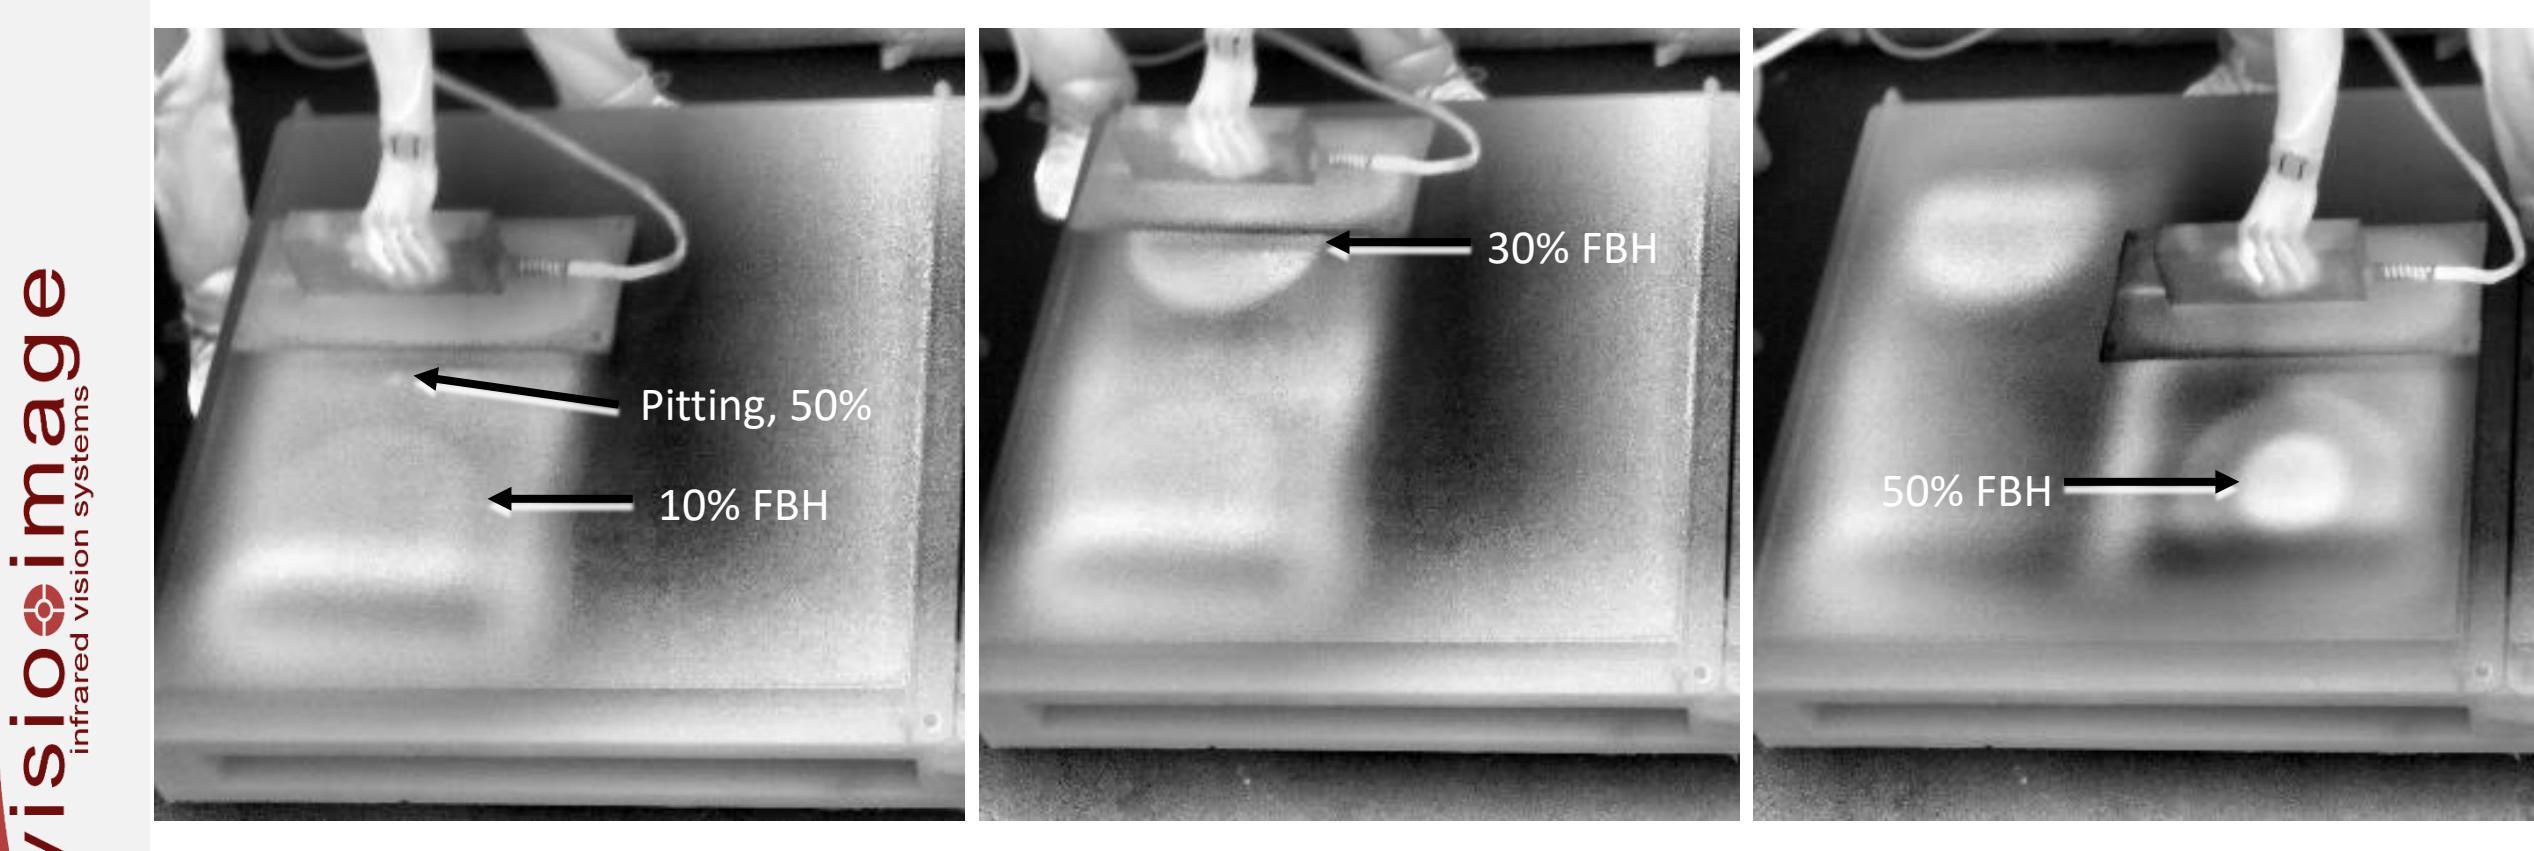
### Baseline: general + pitting corrosion 9 mm plate

Defects that vanish quickly are better observed in video or real-time rather than still images.
Inspection speed can be determined by comparing video length (time) to the length (size) of the test part.

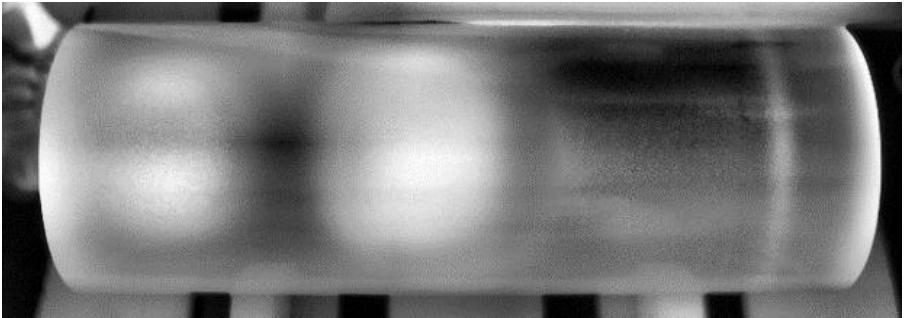
#### Steel 80

A rectangular flat coil is not well-suited for pipes.
 A smaller or curved coil may potentially yield better results.

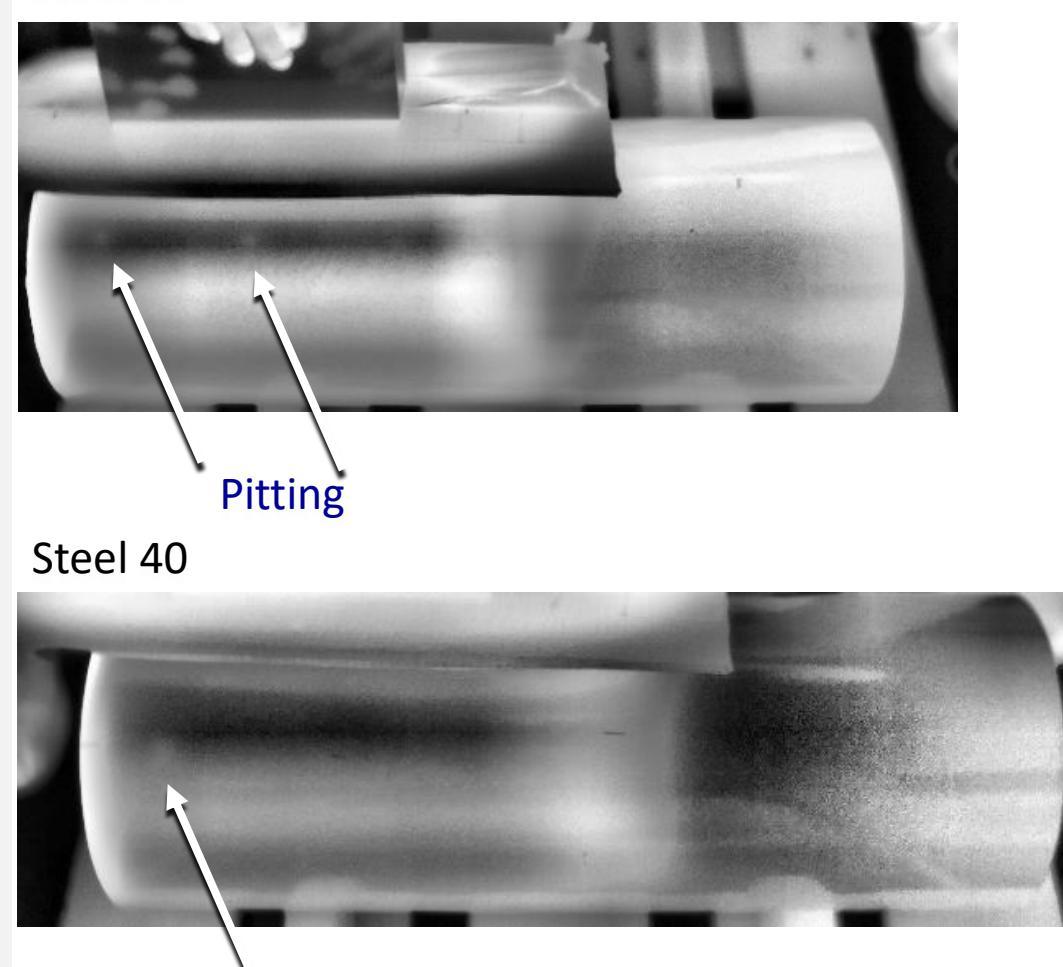
Steel 10

Pitting corrosion in the 80 steel is not visible. However, with minimal time processing using a computer, the pitting can be easily detected. An example is shown below using processing type PCT EOF3 and 200 frames, clearly revealing all the simulated pitting corrosion in the 80 steel (same acquisition) below:

- A rectangular flat coil is not well-suited for pipes. A smaller or curved coil may potentially yield better results.

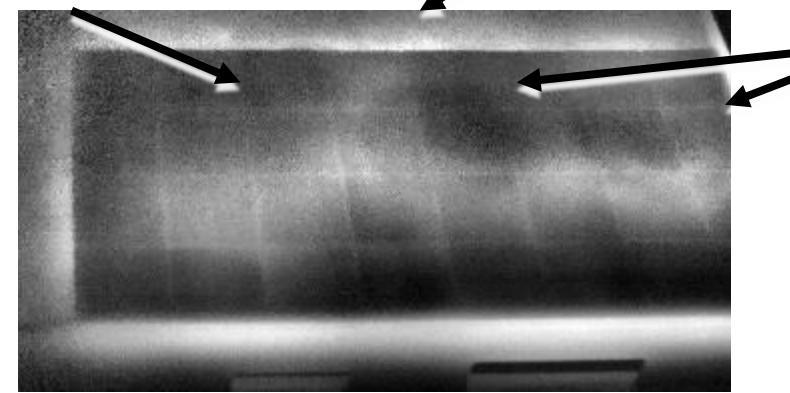
2 circles. The one on the right has a double step

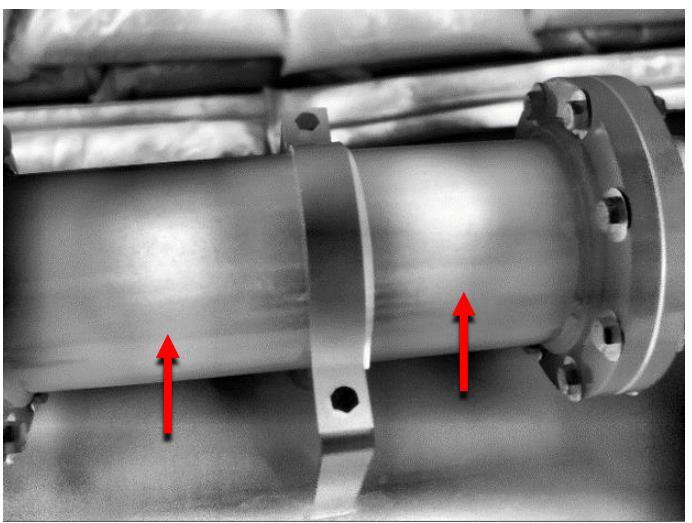
#### Section 6

A rectangular flat coil is not wellsuited for pipes. A smaller or curved coil may potentially yield better results.

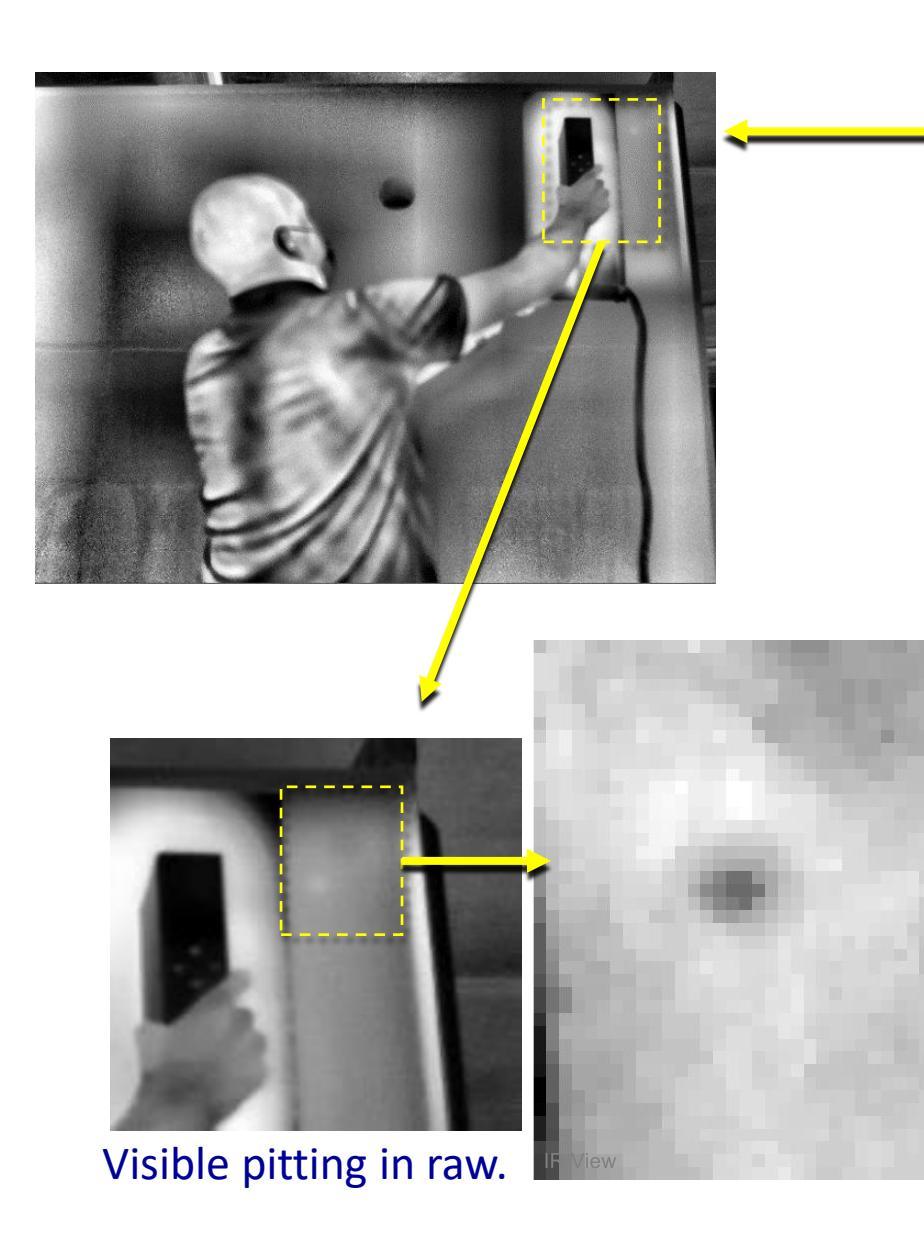
Advanced processing with PCT EOF5 using 91 frames can clearly reveal the pitting corrosion.

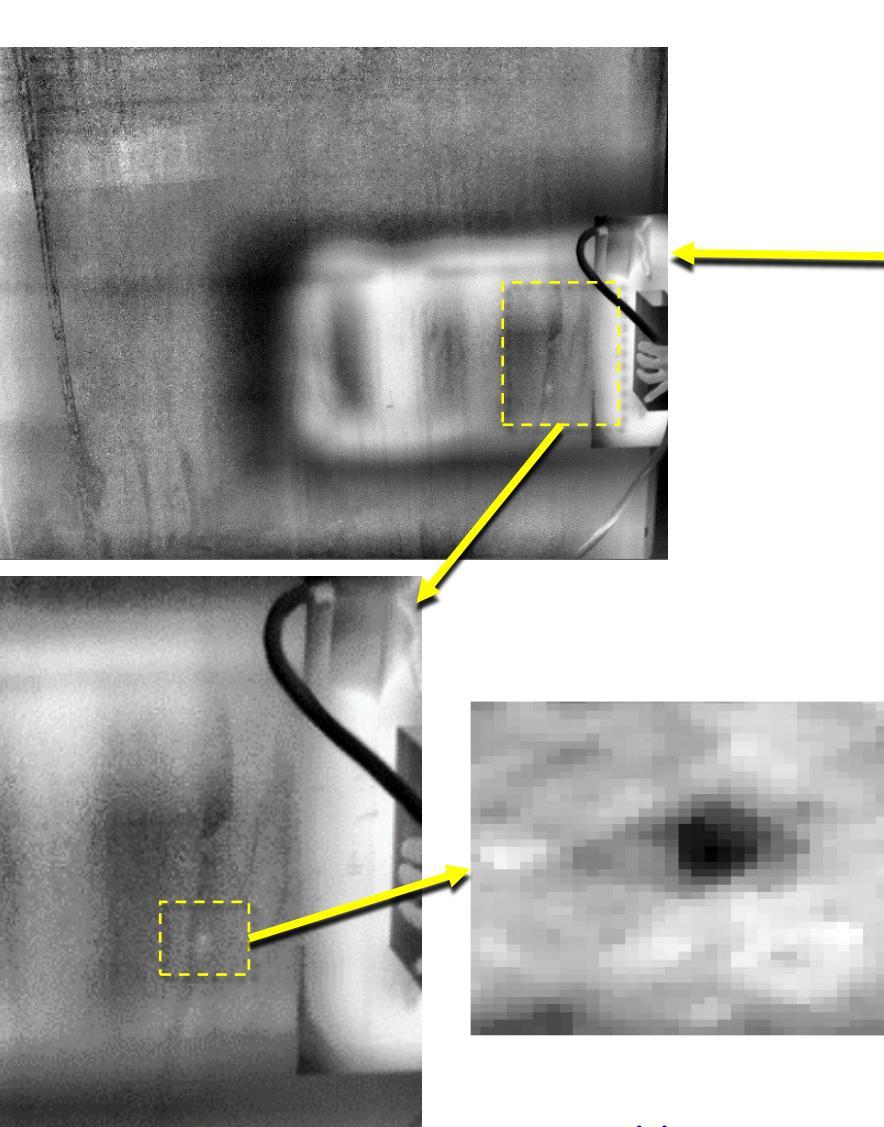
# Hull plate

Advanced processing with PCT EOF3 using 69 frames can clearly reveal the pitting corrosion.

Pitting visible in RAW.

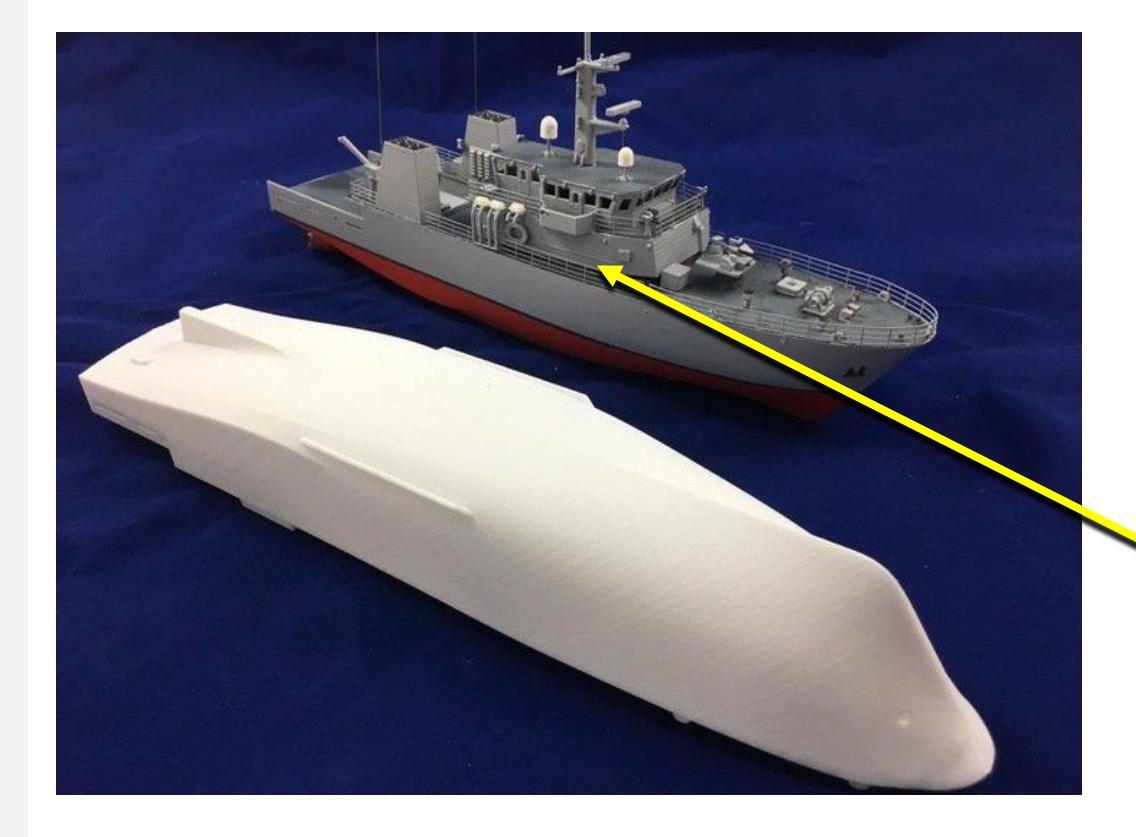
Side of the cabin, close to the ground/deck surface.

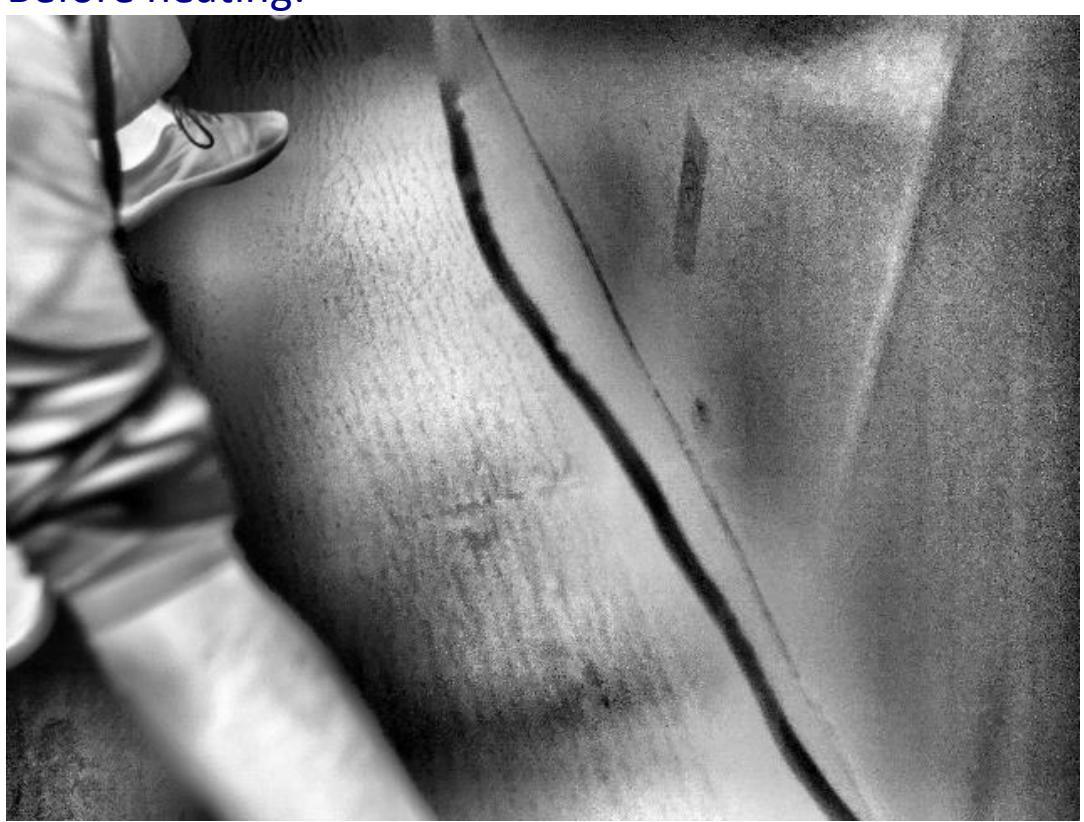
After heating, sub-paint surface corrosion, bubbles, and pitting (visible with the naked eyes) appear as black spots:

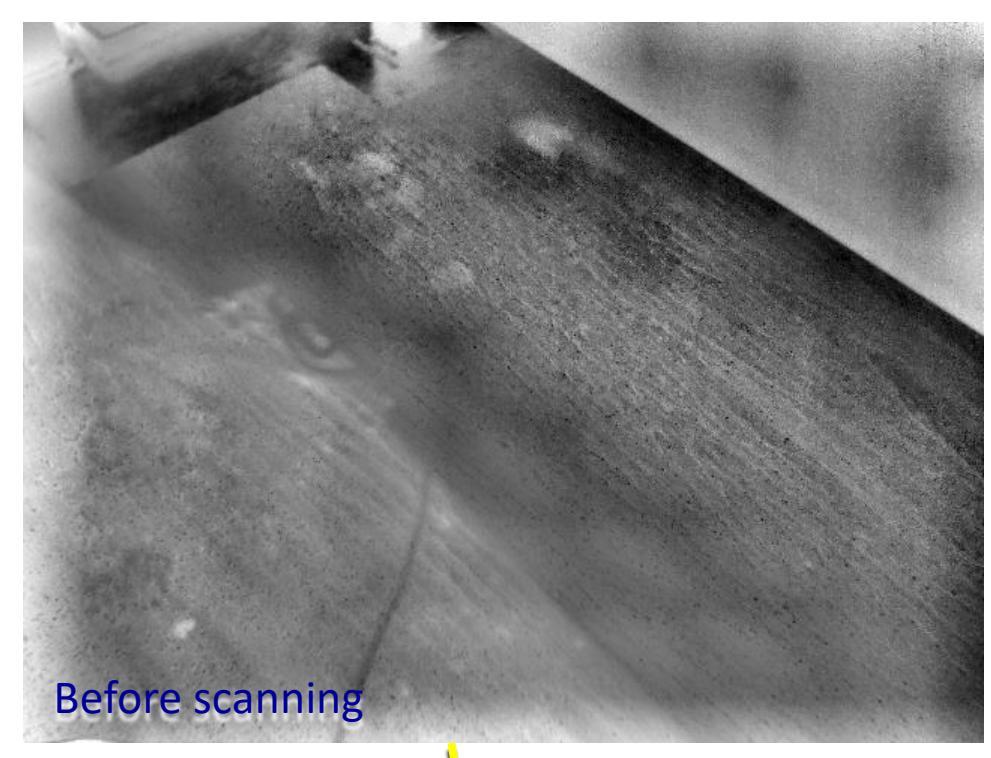
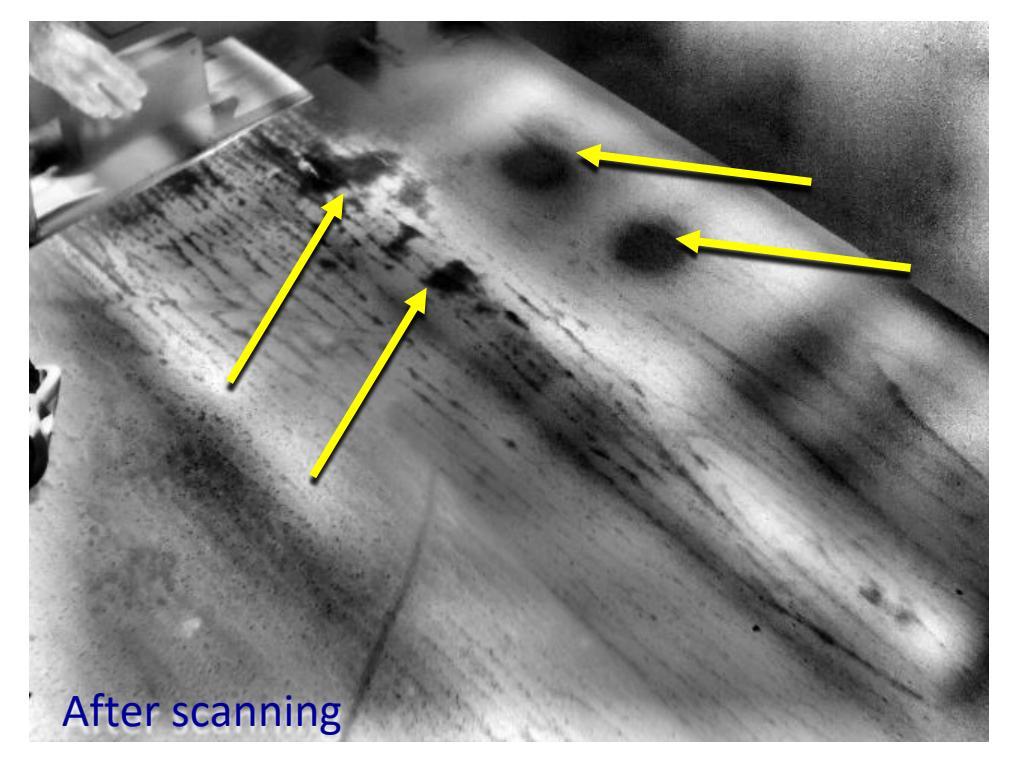
General corrosion spot hidden under the paint, with a visible cavity or lack of material that can be observed with the naked eye.

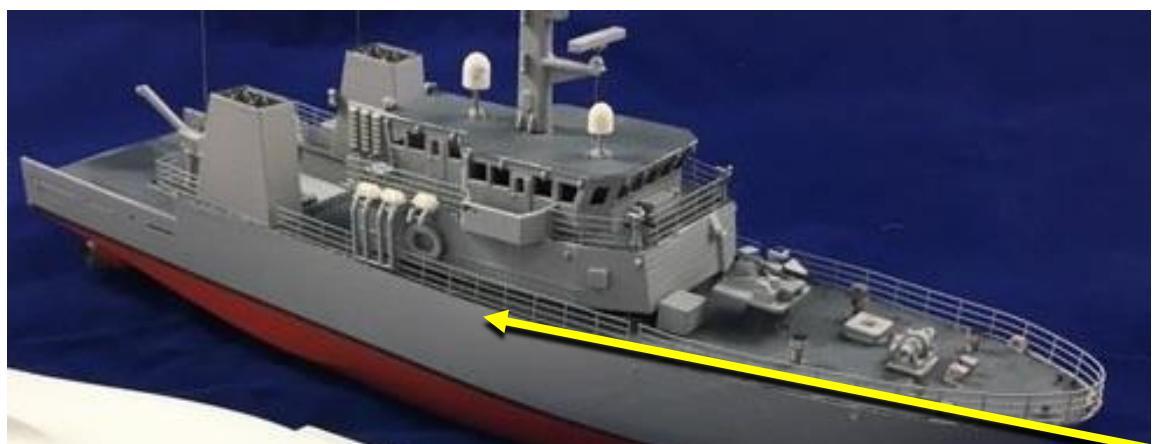
#### Upper hull accessible from the deck. Sound structure.
